Analysis of Pavement Construction on a Sample Forest Road Section in Sarıyer Region

Tolga Öztürk^{1*}, Necmettin Şentürk¹

¹Istanbul University Faculty of Forestry Department of Forest Construction and Transportation 34473 Bahçekoy/Istanbul

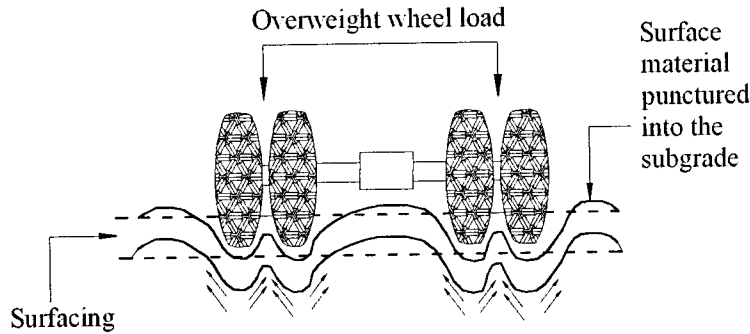
Figure 1. Shear failure of a road surface because of overweight wheel load
Şekil 1. Tekerlek yükü altında yol yüzeyinin biçim değişiklikleri
(Keller and Sherar, 2003)

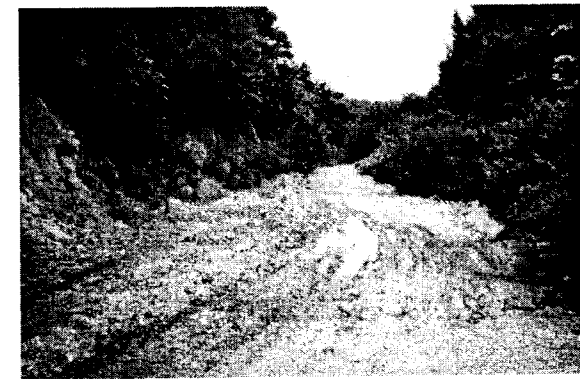
The observations of the sample road prior to the pavement activity indicated that ditches were filled and some parts of the road surface were deformed. Based on the field investigation, no passage could be provided, due to excessive deformation on some parts of the road. The further investigation indicated that damages have occurred on head wall parts of drainage structures and on culvert aprons (Figure 3).

Figure 3. The conditions of 02 code forest road, ditch, and roadbed prior to pavement activities (Photo: T.Ozturk)

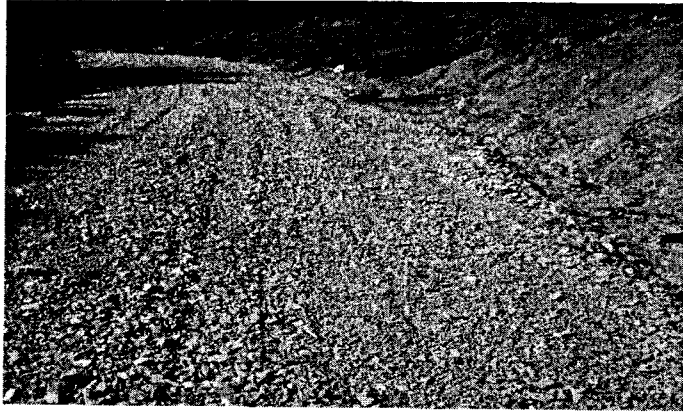
In the last part of the pavement, scattered material was tightened by a road roller. Due to insufficiently tightening and unevenly distributing the materials, the materials have been scattered throughout the road after passing a winter season (Figure 7). On the other hand, since the side ditches could not be opened enough when locating pavement, the ditches could not function well and the materials have caused damage to the surface of the road, following winter and spring rainfalls. Suitable materials have been used for pavement, which means that, in the swamps, large materials were used, whereas, in the regular road structure, small materials were preferred. In Table 3, the results from the sieve analyses of pavement materials were listed, considering thick, normal, and thin materials.

Figure 7. The condition of a part of paved road – one year later (Photo: T.Ozturk)
Şekil 7. Bir yıl sonra üstyapı yapılmış yolun bir bölümünün durumu

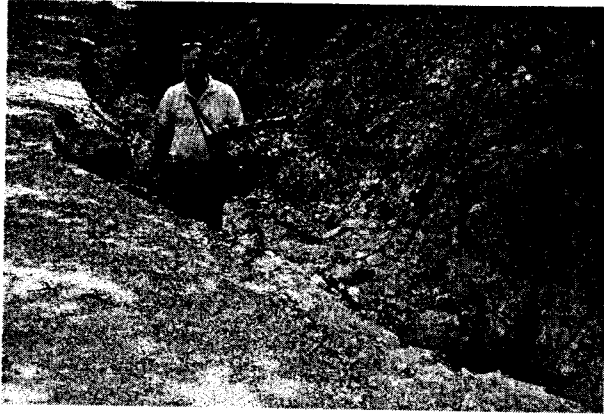
During the road construction work, culverts and concert pipes were needed within nine different points of the forest road with 02 code. Then, it was contemplated that this problem was solved by constructing culverts and concert pipes in a particular size. Due to constructing insufficient number of culverts and concert pipes in necessary places, water from rainfall and cut slopes have been accumulated in side ditches and could not be transferred across the road, and thus, the road and its coat were always left humid and damped.

As a result, when heavy vehicles and trucks were driven, the road has been seriously deformed and damaged. On the other hand, the scattered materials were sunk into the ground and could not function well.

The trees, trunks, soil, and other materials were filled in the entrance and exit of the culverts and concert pipes, and blocking overflow were cleared by a small excavator. Therefore, the constructions have been functioned again. Then, throughout the road, it was investigated that parts of the some culverts and concert pipes were broken and dropped into the creeks. As a solution, it was recommended that the structures should be repaired and their maintenance work should be carried out regularly. Deformation at ditches and lost of pavement materials are showed in Figure 8.

Figure 8. Deformation at ditches and lost of pavement materials (Photo: T.Oztürk)
Şekil 8. Üstyapı materyalinin kaybı ve hendeklerdeki deformasyon
