## FAÇADE CONSERVATION OF AN EARLY 20<sup>th</sup> CENTURY APARTMENT BUILDING IN ISTANBUL

Ahmet ERSEN, Alper ÜNLÜ, Ahmet GÜLEÇ

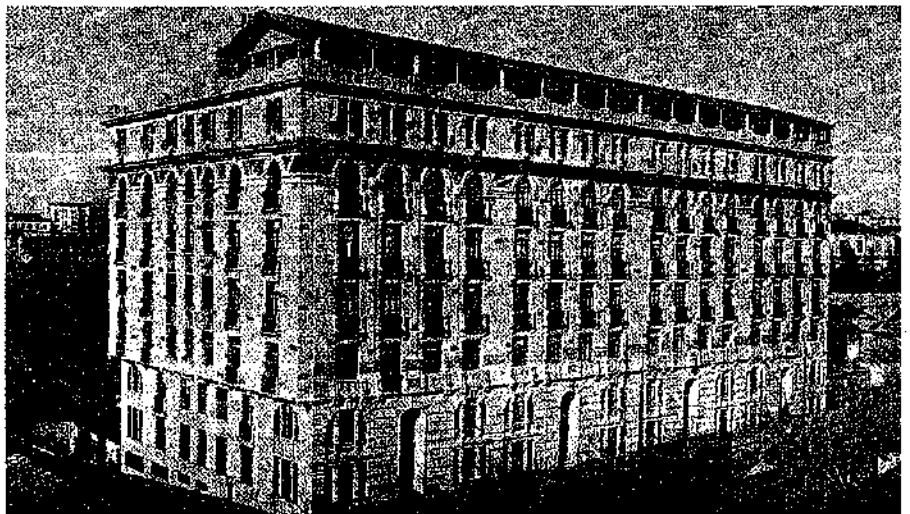
Figure 1. An old photograph of the Matchka Palace (Palazzo Matchka) in the first quarter of the 20th century.

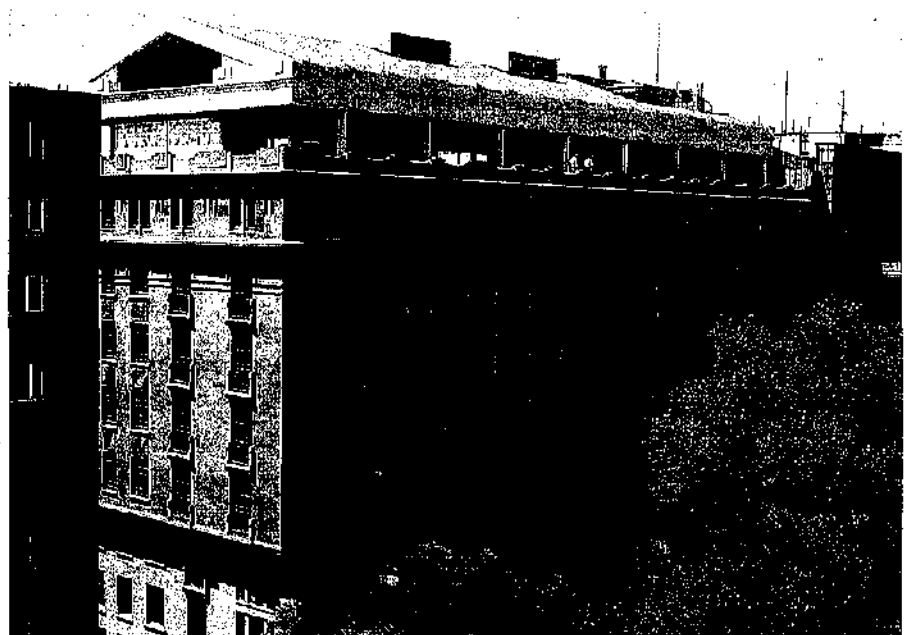
Figure 2. Matchka Palace after restoration.

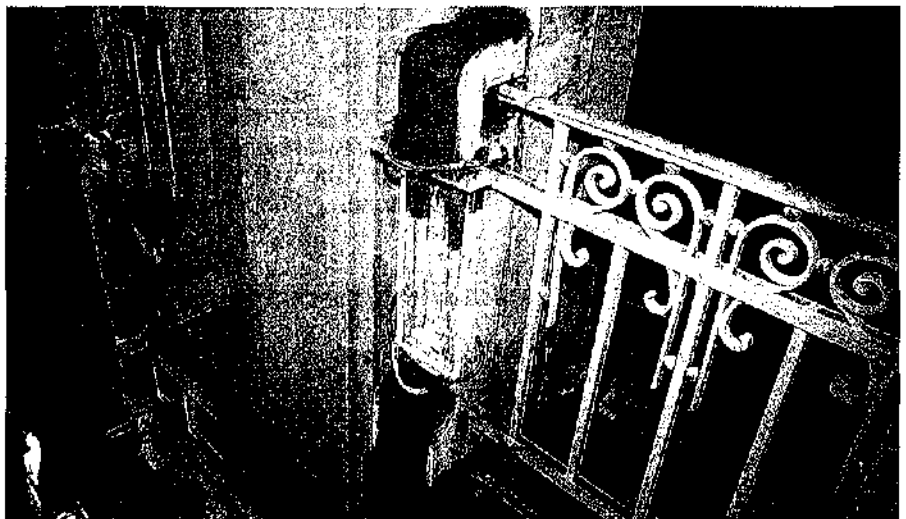
Figure 6. Plastic repairs, wooden forms and the repair mortars.

If large masses were to be reproduced or reintegrated, stainless steel rods of 6-8mm diameter were used for the reinforcements, and the reproduction mortars were cast into wooden mouldings. The original and the reintegrated parts were micro-blasted to obtain natural and matching surface textures.
