**A new record for Turkish Mycota: *Serpula lacrymans* (Wulfen) J.Schröt**

This fungi specimen is founded in Dolmabahçe Palace at the time of restoration – conservation processes; it has been identified as *Serpula lacrymans* (Wulfen) Schröt and registered for the first time in Turkey. This fungus is defined and photographed. The photo of the spores seen under the light microscope is given in this study.

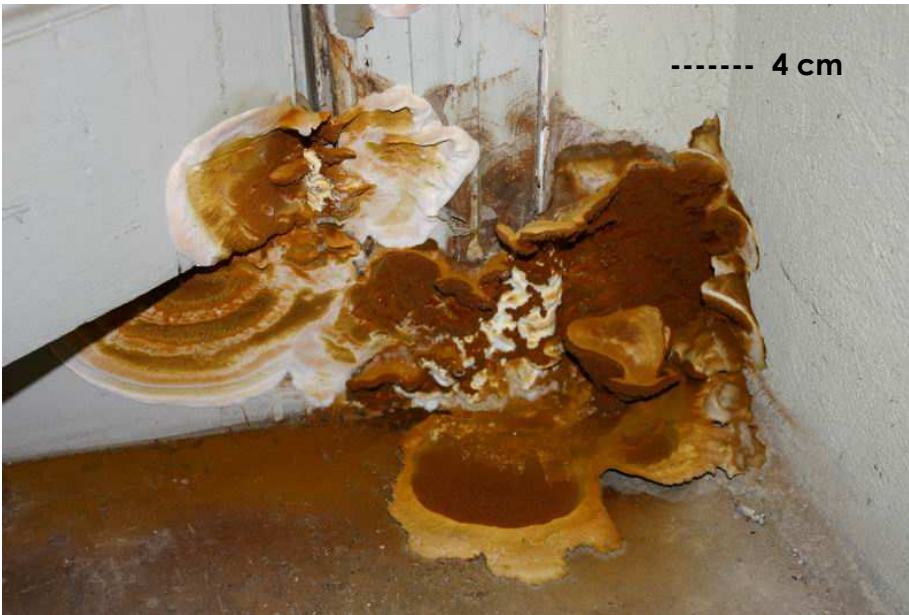
The fruit body of *Serpula lacrymans* (Wulfen) P.Karst. is embedded in a surface of 36 cm in length and 13 cm by height. The horizontal surface is round shaped like a disk and the vertical surface is in the shape of small brackets. The vertical surface has favourable diameters of 4-18 cm in diameter and 0,4- 0,8 cm in thickness. The fungus is spongiform and pulpy in texture so that can be easily separated from the substrate. The fruiting body is at first yellowish, scarlet in colour and as the fungus decays and gets elder changes into a morello brownish colour. The himenium surface is wrinkle and corrugated, also moist and the edges has marginal zones of white and well bordered. (Figure 1). The young fruiting body of the fungus has a pleasant fungous odour, as it gets older becomes foul and unpleasant. The spores are massive and rusty red in colour. The spores are ellipse in shape, smooth and yellowish brown in colour. The spores are 11-13 µm x 5.5-8 µm in dimension (Figure 2). Some of them have droplets. Basidia slendery clavate has 4 sterigmata and shows basal clamped pattern. The hyphae are colourless and the septa with clamps. Rhizomorphs are brownish and has thick- walled and with crystals.

Figure 1. Fruiting body of *Serpula lacrymans*

The specimens of *S. lacrymans* were obtained from pine wood used at the Dolmabahce Palace in Istanbul; June, 2001. The fungal specimens were photographed in original place where it was first founded; the macroscopic features were noted and transported to the Plant Diseases and Microbiology Laboratory of Science and Letters Faculty, Marmara University for microscopic evaluation.

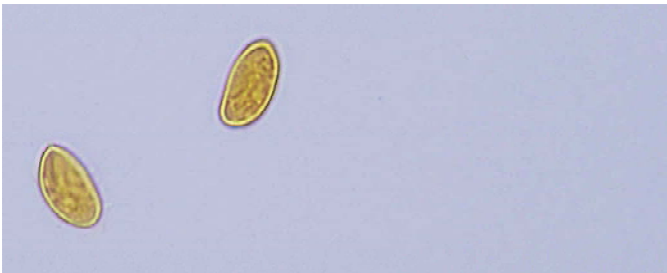
Figure 2. Spores of *Serpula lacrymans* in LM

In the microscopic examination of the fungus the below findings were noted. The fungi were treated with 20 % KOH solution for softening and preparation for microscopic examination. Olympus Cx41 Light microscope was used for microscopic examination. Then the microscopic photos were taken with Image-Pro Express (Micropublisher 5.0 RVT) imaging device which is compatible with this microscope. The fungi were identified according to Jordan (1995) and Breitenbach, Kranzlin (1986).
