Analysis of Pavement Construction on a Sample Forest Road Section in Sarıyer Region

Tolga Öztürk^{1*}, Necmettin Şentürk¹

¹Istanbul University Faculty of Forestry Department of Forest Construction and Transportation 34473 Bahçekoy/Istanbul

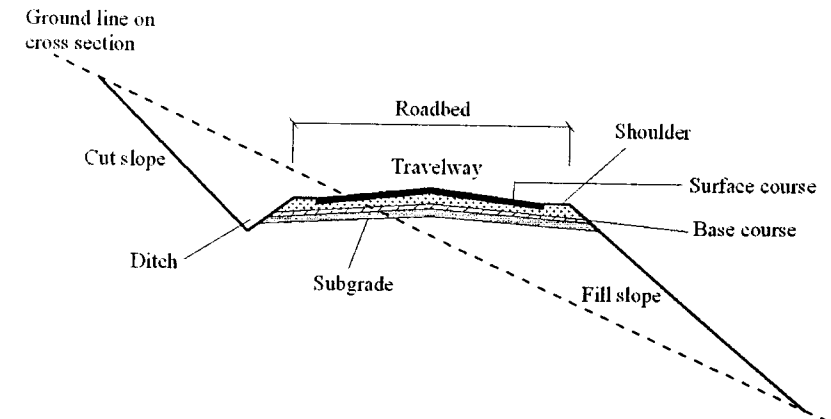
Pavement constructed on a forest road limits the movement of the ground to sideways and therefore it prevents a vertical deformation (GDF, 1984). Pavement of a forest road is divided into two layers including surface course and base course (Figure 2).

Figure 2. Road template elements
Şekil 2. Yol enkesit elemanları

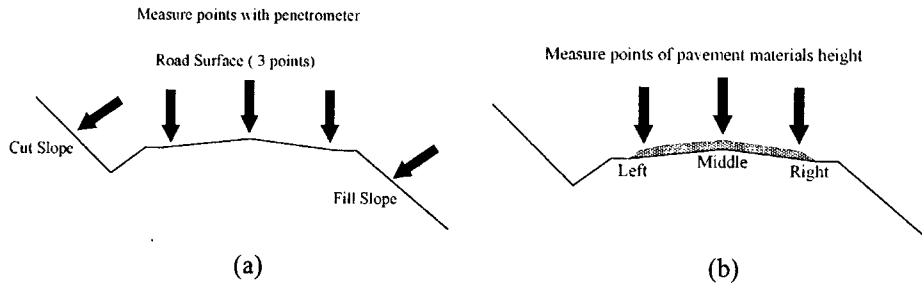
Along the roadway, cross sections were taken at every 50 meters and soil compaction value was measured from 5 different points on each cross section by using a Eijelkamp pocket penetrometer; one point on cut slope, one point on fill slope, and three points on travelway of the road template (Figure 4). The average measurements were computed for two stages of the sample road where the first stage is from cross section 1 to 20 and the second stage is from cross section 21 to 50.

Figure 4. a) Measurement points where soil compactions were taken by penetrometer
b) Measurement points where thicknesses of the pavement materials were taken
Şekil 4. a) Penetrometre ile toprak sıkışmasının ölçüldüğü noktalar
b) Üstyapı materyalinin kalınlığının ölçüldüğü noktalar

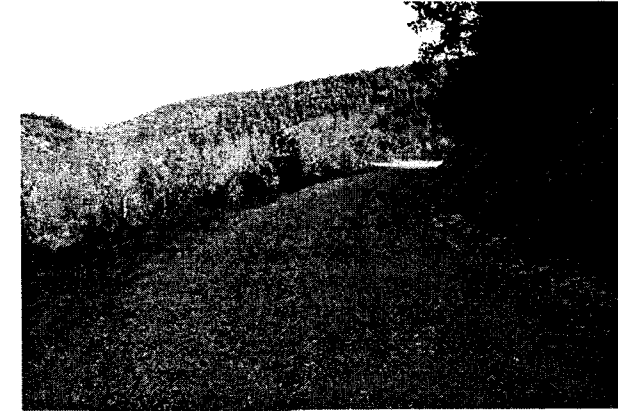
It has been observed that three different sizes of materials were used along the roadway. Thick material has been used on the wet and marshy road surfaces and normal-size and smaller material has been used on sound road surfaces. The materials were transported by double-shafted BMC and Mercedes branded trucks and spread on the road surface by a Caterpillar loader. After the pavement material was spread on the road, the pavement was compacted by a Dynapa type cylinder. Figure 5 indicates the

final status of pavement. After the pavement activity, harvesting operation was conducted in the forest around sample road and trees were extracted by using the tractors through the sample road. Total timber volume transported was approximately 600 m³.

Figure 5. A view from the forest road after pavement activity (Photo: T.Ozturk)
Şekil 5. Üstyapı çalışmasından sonra orman yolundan bir görünüş

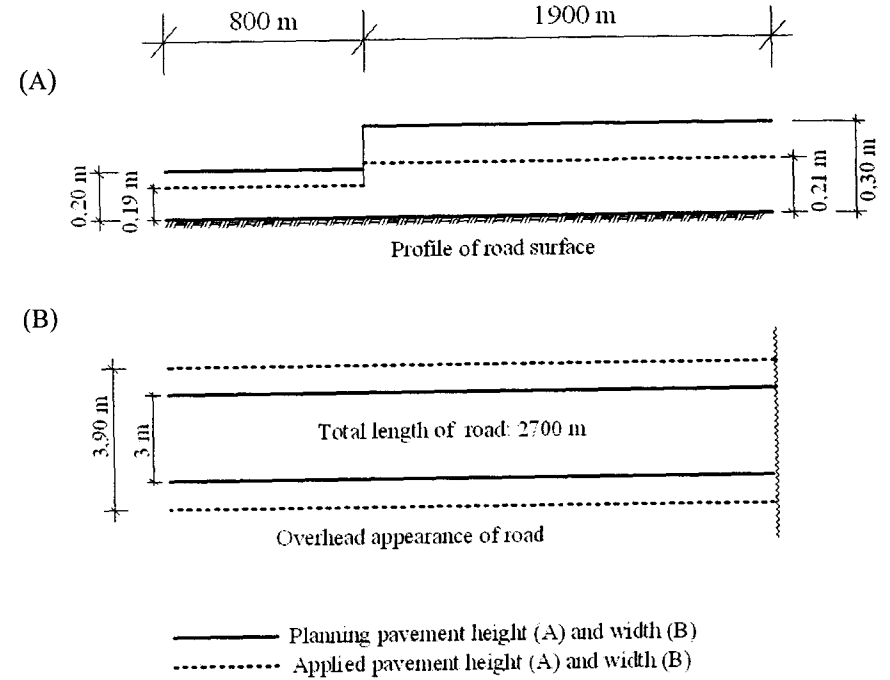
After completing pavement activity, the width of scattered materials was measured as 3.90 meters as an average for the first 1000 meters of the road, while it was measured 3.80 meters as an average for the rest of the road (Figure 6). The reason for such a difference is because of using loader when scattering the materials, instead of grader. Simply, loader cannot scatter the materials evenly and homogenously, therefore, the material thickness became different in different parts of the road. In contrast, grader may take the overflowed materials back to the middle of the road and scatters the materials more homogenous than that of loader.

The quantity of the materials used for pavement, including crossfields, was calculated as 2310 m³. The planned material thickness was similar to the thickness of the pavement material used in the application. The reason for that the material scattering width was wider than 3 meters (3.80 m and 3.90 m).

Figure 6. Thickness and width of planned and applied pavement materials
Şekil 6. Planlanan ve uygulanan üstyapı kalınlığı ve genişliği

During pavement work, the recommended spreading width of the material should be complied. The material that spread wider than it was necessary flows to ditches or downwards from the fill slope and lost. As a result, the material thickness will be lower and more material will be wasted. The materials should be spread on the road by a bulldozer. Bulldozer can distribute the material on the road homogeneously and can better adjust the thickness of the spread material.
